NAVAL RESEARCH LABORATORY Washington, D. C.

AIRBORNE RADIO DIVISION - ENGINEERING ANALYSIS SECTION

AIRBORNE RAD	10 DIVISION - ENGINEERING ARREISIS SECTION	
	11 15 Apr 46,	
	13/7p. 9 Interim rept.	
•	(C) TYPE TEST OF	_
ACSESSIGN for	AN/APS-20A.  C. B. Barnes	
CESTAL WHITE SECTION (	I. W. Fuller.	3
UKA "NOUNCED CELL	- Report R-2809 - (14) NRL-R-2809	
BIST. AVAIL and or S. COTAL		
7	Approved by:	
G. C. Schle	ter - Head, Engineering Analysis Section	
Raymond A. Gordon Acting Supt. Airborne	Radio Division Commodore H. A. Schade, USA Director, Naval Research Labora	
		1
	Preliminary Pages	0150
	Plates Distribution List.	6
	DOWNGRAPUD AT 2 YEAR INTERVALS: DECLARATION OF LINES	
Problem No. S2111T-C	MAY 8 1956	4
L	56AA 19770 -	T.
AT 251 95	- UNCLASSIFIED ey

The AN/APS-20A is a high-powered Airborne Early Warning radar system. It is capable of detecting and mapping targets located within the search horizon determined by the airpiane altitude. The information thus obtained is reproduced on two PPI tubes within the plane as well as being simultaneously relayed by radio relay equipment to some remote point and being reproduced there. The results of the noise and interference tests on this eq

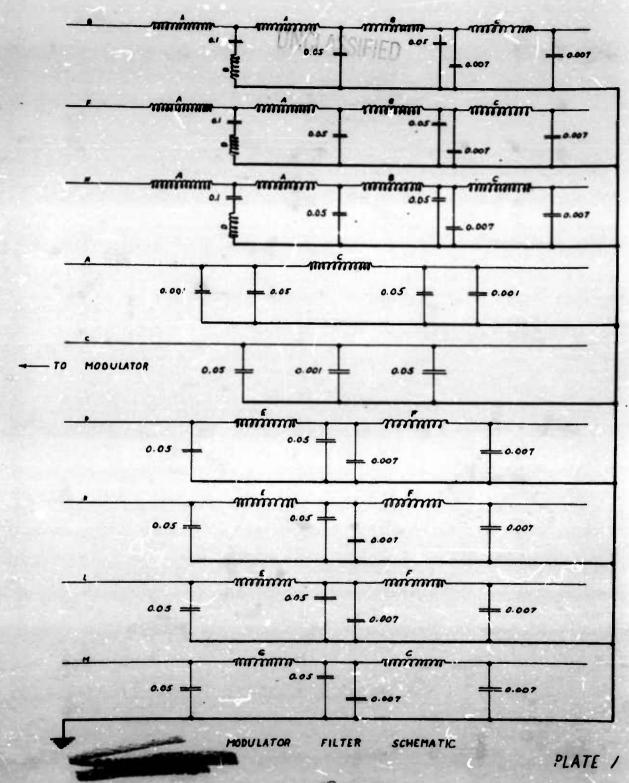
# COIL DATA MODULATOR FILTER

- Upon completion of the radiated noise measurements, conducted noise checks were made at the distribution box with a Ferris Model 32-B noisemeter. The results of these measurements can be found in Table VI. The conducted noise on the A-C power leads, with the modulator operating, was over 100,000 microvolts. A filter was designed and installed between the modulator cable and the modulator. (Refer Plate 1 and Table VII). The results of this filter can be seen in Table VI. The modulator trigger was rerouted so that it went directly from the added filter unit to the synchronizer and did not go to the modulator control box.

- The correction used was the filter shown in Plate 1 and Table 7.
- Measurements were made with a Ferris model 32-B Noise Meter.
